# A Balancing Act

A vibration problem arose at an Open Cycle Gas Turbine. Following an outage on the four gas turbines and two SSS clutches, the machine returned to service with unacceptable vibration levels on some generation runs resulting in a significant loss of commercial operation.

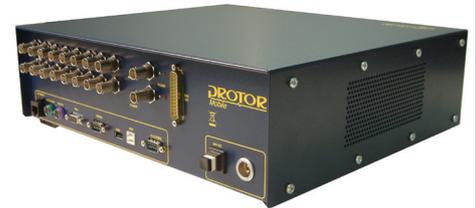
**PROTOR-mobile**  
Portable vibration condition monitoring  
1 x 16-channel PROTOR-mobile

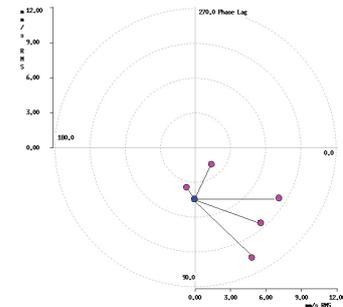
Pre-balance vibration data

The complexity of this arrangement becomes evident when we consider that the overall imbalance forces throughout the system change dependent on the clutch engagement angles for both clutches. It was found that at certain engagement angles the resultant forces were significant enough to make the vibration levels unacceptable on the generator and exciter bearings.

From this spread of engagement angle data, the first order amplitude and phases readings were displayed. Note that at some engagement angles the measured 1st order vibration exceeds 9 mm/s RMS.

To assess the resultant balance states the generator is held at 3000 rpm under synchronous compensation mode and each clutch disengaged and re-engaged a number of times until vibration data at a full spread of engagement angles was collected.

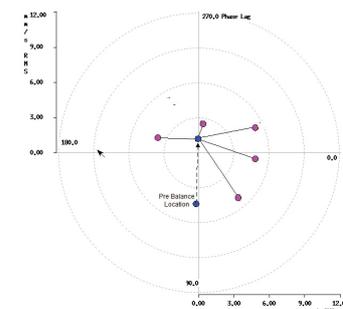
Post-balance vibration data

After careful analysis an in-situ balance was performed which resulted in a state where the vibration data for all clutch angles was acceptable (all below 6 mm/s RMS).
